# LIFEBOAT DRILL SAFETY ISSUE 2009

## 1 AIMPE LIFEBOAT DRILL POLICY: for davit-launch & freefall-launch lifeboats

# LIFEBOATS

## 4. Don't Rely on Stainless Steel; some grades may rot!

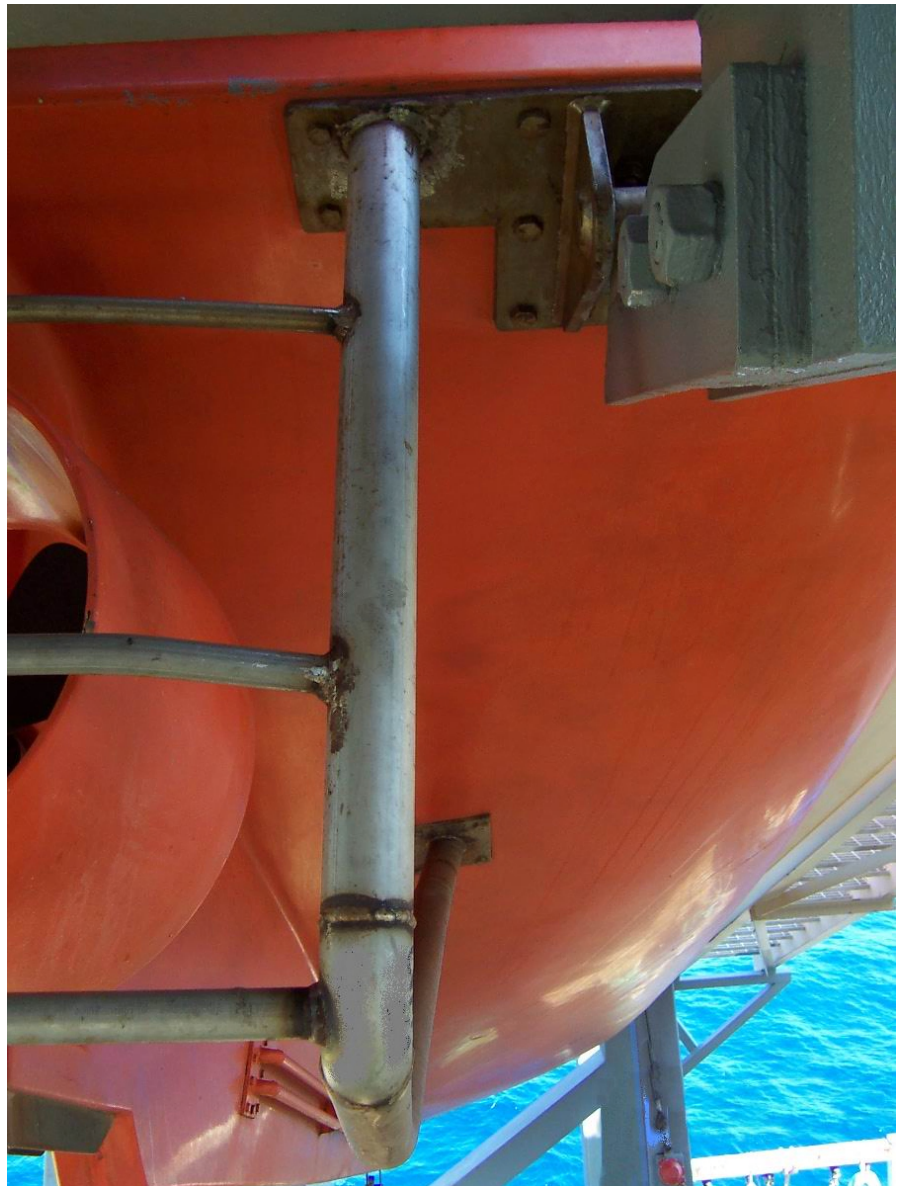
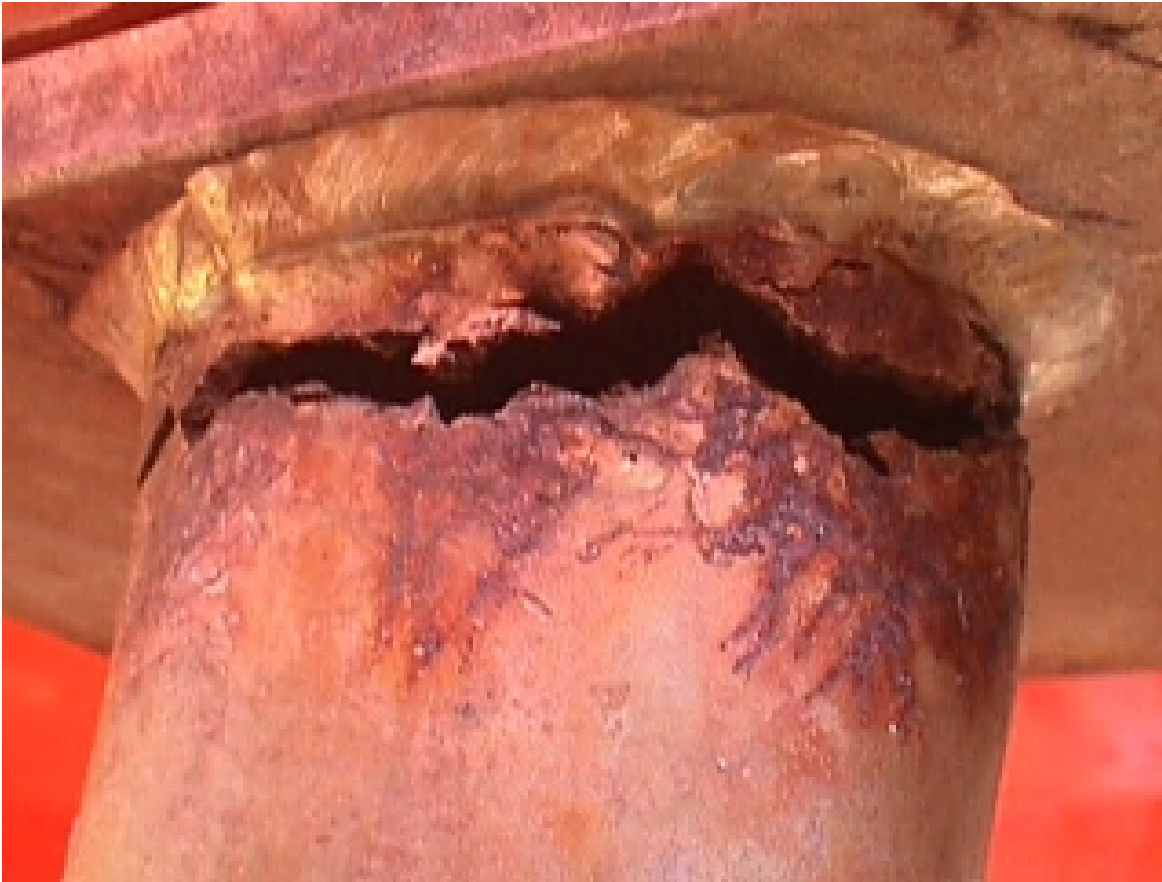
Experience gained in the Timor Sea and off the Pilbara coast has reached an unequivocal conclusion that 304 / 302 grade (Austenitic) stainless fasteners suffer from CSCC under normal service conditions on deck due to the high ambient temperatures and solar radiation which often raises metal temperatures above 70 Deg C. These fasteners are identified by head markings as per the attached spreadsheet.

The insidious thing about this failure mechanism is **that there is no prior warning**, so NDT of parts will often show no defects.

Cracks can propagate to full material thickness within a few weeks. The first warning is usually a bolt head missing or found on the deck or alternatively sheared heads when trying to disassemble components.

See attached spreadsheet, summary and photos of lifeboat propeller guard.

AIMPE members have found A4 or 316L to be suitable for most bolting applications, however this material is totally unsuitable for warm stagnant seawater applications (particularly piping) due to extremely rapid pitting corrosion to full material thickness within about a month. (exacerbated by the presence of hydrogen sulphide from microbial action or sour crudes.)

Woodside has a total ban on the use of 302 / 304 grade of stainless steels, except for "special duty" such as in superheated steam service (ASTM - Grade B8) or in submerged pump applications where temperatures do not rise above seawater temp.
